**Flood Control Project Maintenance
Levee Inspections**

Fall 2008 Levee Maintenance Deficiency Summary Report

Reclamation District No. 0563

Waterway			Bank	Unit Miles
Unit No. 01 Georgiana Slough (Tyler Island)			Left	12.40
	Spring (March - May)	Summer (June - August)	Fall (September - November)	Winter (December - February)
Date of Inspection	3/18/2008		9/22/2008	
DWR Inspector	Richard Willoughby		Richard Willoughby	
Accompanied By				
Unit Maintenance Rating (Fall Only)			U

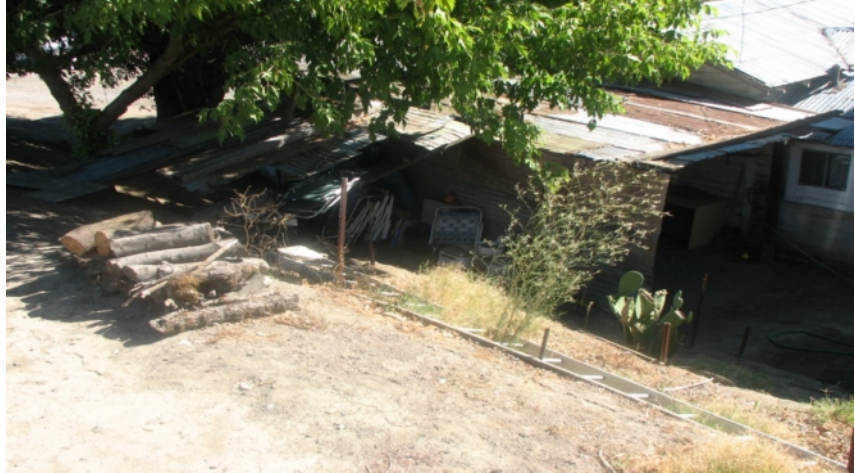
Levee Mile Report Line	12
Start Levee Mile	1.25
End Levee Mile	1.25
Location	
Category	Earthen Levee
Item	Encroachments
Looking at shed at landside toe.

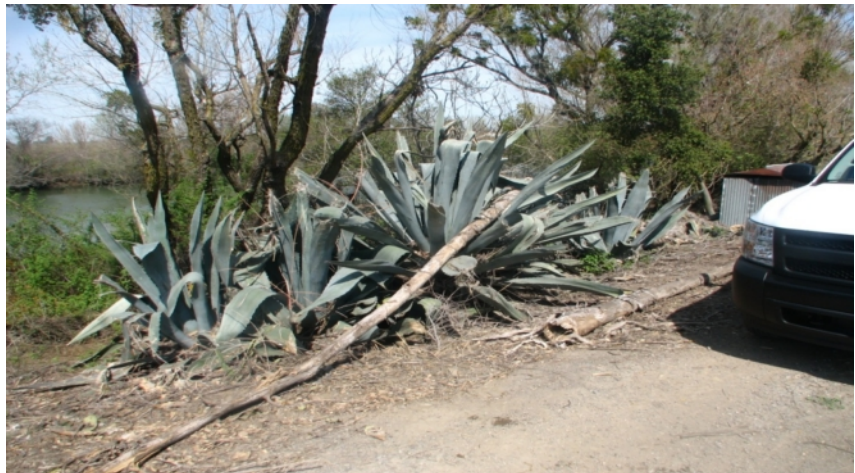
13	1.44	1.48	Earthen Levee	Vegetation	WS	M	Remove the wild growth other than native grasses from the levee slopes. Inspector Comments: Remove century plant from waterward shoulder.	38.224280 ° -121.534377 °	38.224000 ° Y -121.535038 °		6
14	1.48	1.84	Earthen Levee	Vegetation	LS	M	Remove the wild growth other than native grasses from the levee slopes.	38.223977 ° -121.535140 °	38.222732 ° -121.541382 °		58
15	1.51	1.77	Earthen Levee	Vegetation	WS	M	Remove the wild growth other than native grasses from the levee slopes.	38.223850 ° -121.535645 °	38.222958 ° -121.540060 °		59
16	1.86	1.86	Earthen Levee	Encroachments	LS	M	Stairways Inspector Comments: Retaining Wall at landside toe of levee. New stairs and flower box on landside slope.	38.222702 ° -121.541678 °	38.222702 ° Y -121.541678 °		60
17	2.14	3.52	Earthen Levee	Vegetation	WS	M	Remove the wild growth other than native grasses from the levee slopes.	38.220047 ° -121.542943 °	38.206013 ° -121.540668 °		61

Levee Mile Report Line	13
Start Levee Mile	1.44
End Levee Mile	1.48
Location	
Category	Earthen Levee
Item	Vegetation
Century plant on waterward shoulder at LM 1.42

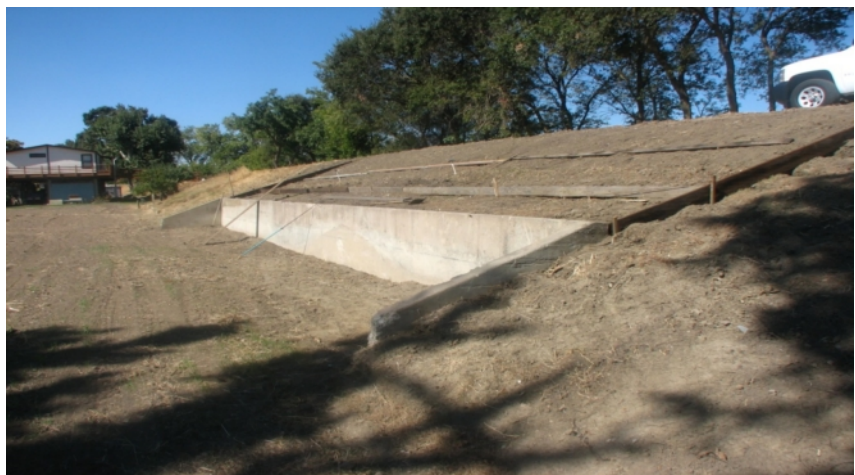
Levee Mile Report Line	16
Start Levee Mile	1.86
End Levee Mile	1.86
Location	
Category	Earthen Levee
Item	Encroachments
Unauthorized retaining wall on landside toe.

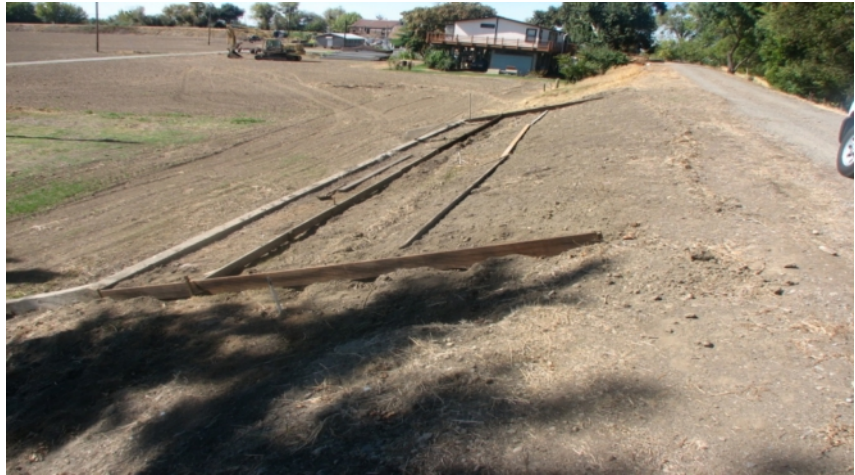
Levee Mile Report Line	16
Start Levee Mile	1.86
End Levee Mile	1.86
Location	
Category	Earthen Levee
Item	Encroachments
Flower box above retaining wall on landside slope

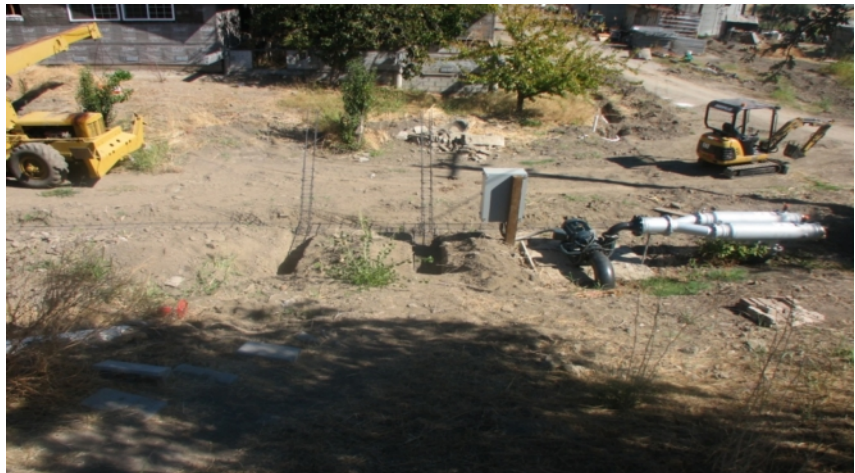
24	2.68	2.68	Earthen Levee	Encroachments	LS	M	Pipe Inspector Comments: Landowner has installed a pump booster at landside toe connected to a existing pipe. Also installing a 500 feet retaining wall along a existing ramp and at the landside toe.	38.214248 ° -121.537633 °	38.214248 ° -121.537633 °	Y	63
25	2.69	2.88	Boat Survey	Boat Survey Erosion	LS	U	Inspector Comments: tree hazards, slumping	38.213940 ° -121.537696 °	38.211680 ° -121.535602 °		932
26	2.75	4.71	Earthen Levee	Vegetation	LS	M	Remove the wild growth other than native grasses from the levee slopes.	38.213363 ° -121.536982 °	38.193347 ° -121.550815 °		64
27	2.79	2.79	Earthen Levee	Encroachments	WS	M	Tree or limb	38.212782 ° -121.536427 °	38.212782 ° -121.536427 °		15
28	2.86	2.86	Earthen Levee	Encroachments	WS	PO	Equipment	38.212180 ° -121.535803 °	38.212180 ° -121.535803 °		65
29	2.93	2.95	Earthen Levee	Encroachments	LS	U	Garbage	38.211282 ° -121.534810 °	38.210955 ° -121.534805 °	Y	16

Levee Mile Report Line	24
Start Levee Mile	2.68
End Levee Mile	2.68
Location	
Category	Earthen Levee
Item	Encroachments
View of pump booster and electrical box at landside toe.

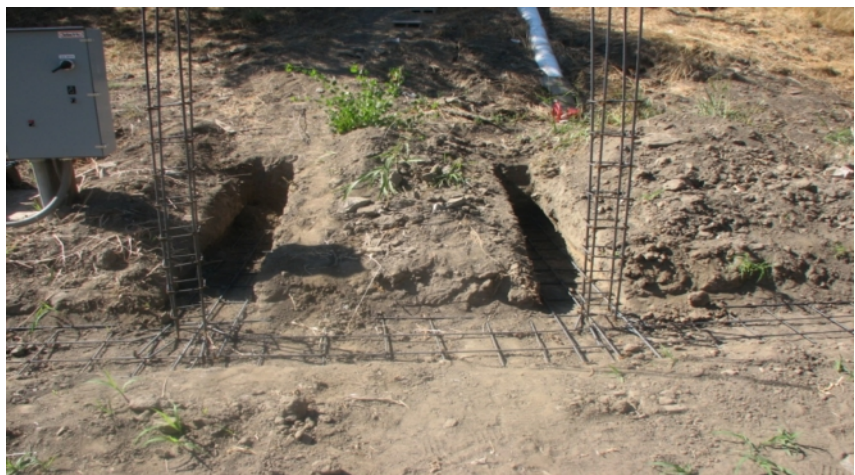
Levee Mile Report Line	24
Start Levee Mile	2.68
End Levee Mile	2.68
Location	
Category	Earthen Levee
Item	Encroachments
Rebar for retaining wall on landside toe.

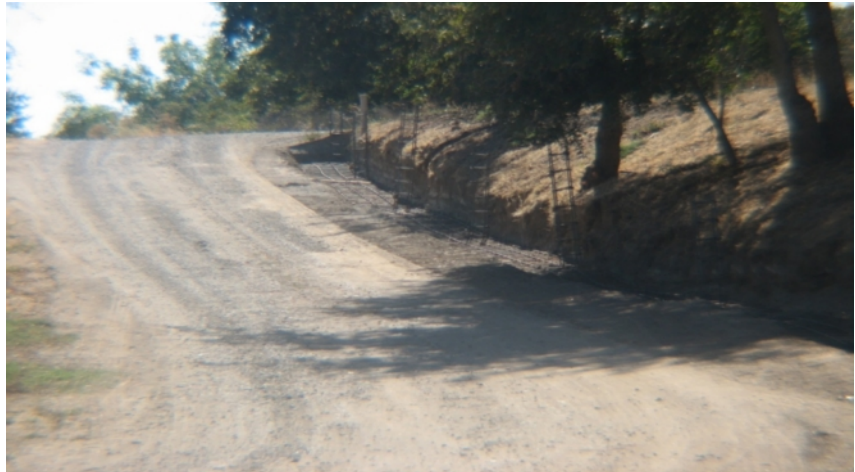
Levee Mile Report Line	24
Start Levee Mile	2.68
End Levee Mile	2.68
Location	
Category	Earthen Levee
Item	Encroachments
Rebar for retaining wall along landside ramp.

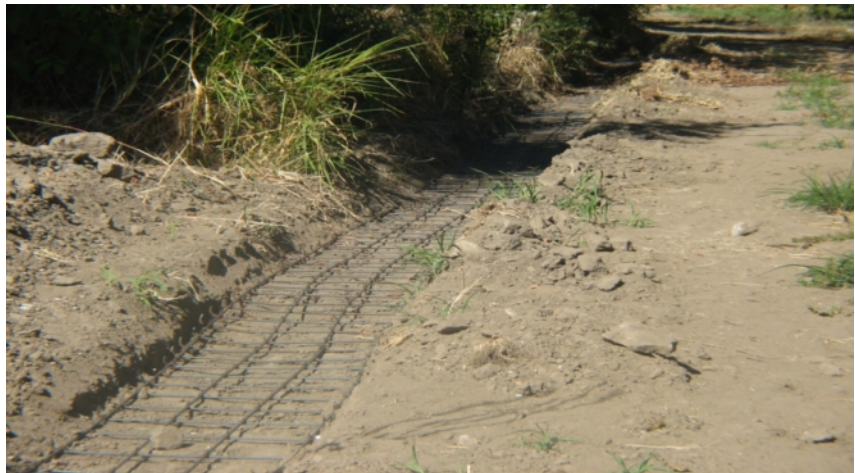
Levee Mile Report Line	24
Start Levee Mile	2.68
End Levee Mile	2.68
Location	
Category	Earthen Levee
Item	Encroachments
Rebar for retaining wall along landside toe.

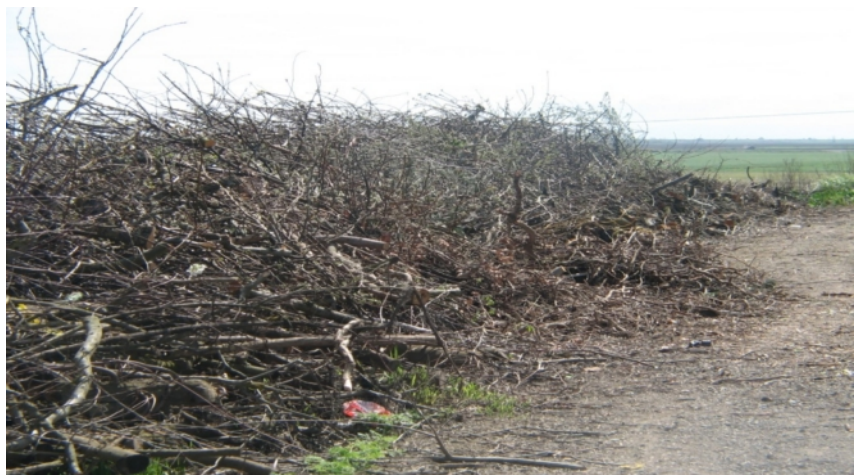
Levee Mile Report Line	29
Start Levee Mile	2.93
End Levee Mile	2.95
Location	
Category	Earthen Levee
Item	Encroachments
Prunings on landward shoulder from LM 2.93 to 2.95

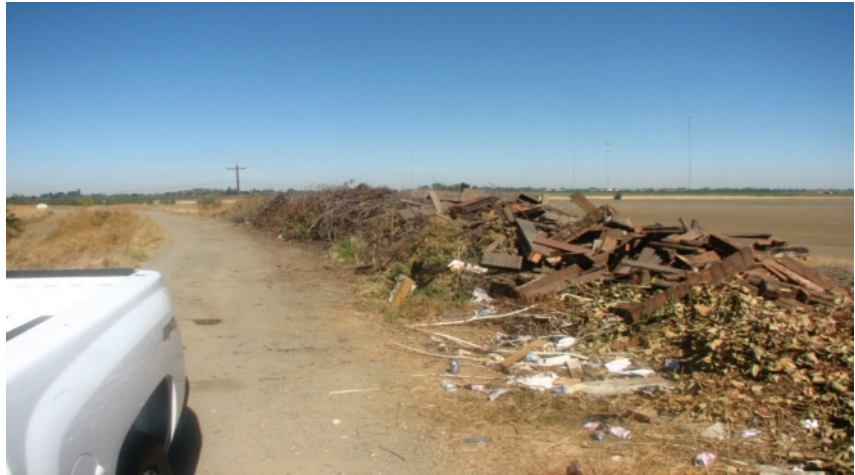
Levee Mile Report Line	29
Start Levee Mile	2.93
End Levee Mile	2.95
Location	
Category	Earthen Levee
Item	Encroachments
View looking upstream at pruning pile.

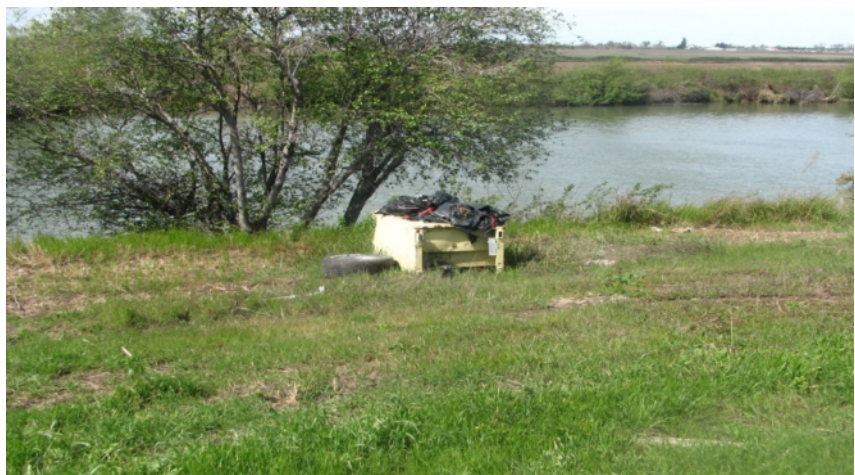
Levee Mile Report Line	35
Start Levee Mile	4.27
End Levee Mile	4.27
Location	
Category	Earthen Levee
Item	Encroachments
Garbage at waterward berm at LM 4.27

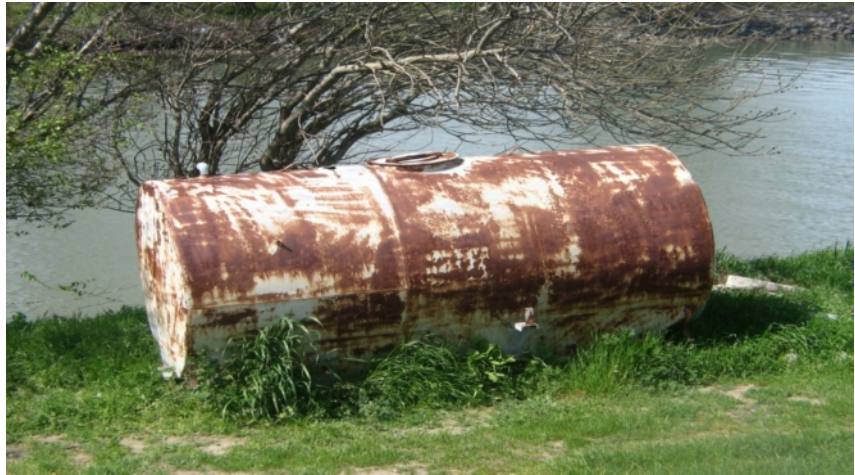
Levee Mile Report Line	36
Start Levee Mile	4.40
End Levee Mile	4.40
Location	
Category	Earthen Levee
Item	Encroachments
Old fuel tank at waterward berm at LM 4.40

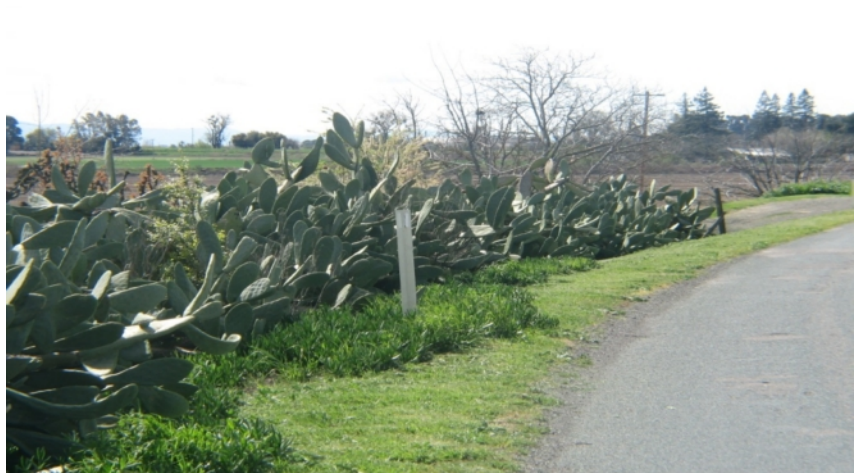
41	6.04	6.08	Earthen Levee	Vegetation	LS	U	Remove the wild growth other than native grasses from the levee slopes. Inspector Comments: Large Cactus on landward slope.	38.181965 ° -121.569913 °	38.181763 ° -121.570447 °	Y	22
42	6.06	6.40	Boat Survey	Boat Survey Erosion	LS	M	Inspector Comments: tree hazards, caves	38.182107 ° -121.570258 °	38.181487 ° -121.576143 °		928
43	6.13	6.13	Earthen Levee	Trim / Thin Trees	LS	M	Trim trees to at least five feet above ground level.	38.181498 ° -121.571325 °	38.181498 ° -121.571325 °		69
44	6.38	6.39	Earthen Levee	Trim / Thin Trees	LS	M	Trim trees to at least five feet above ground level.	38.181273 ° -121.575873 °	38.181217 ° -121.576070 °		23
45	6.42	6.44	Earthen Levee	Vegetation	LS	U	Remove the wild growth other than native grasses from the levee slopes.	38.181062 ° -121.576563 °	38.180977 ° -121.576803 °		24
46	6.44	6.54	Earthen Levee	Encroachments	LS	PO	Fences	38.181030 ° -121.576755 °	38.179430 ° -121.576942 °		70

Levee Mile Report Line	41
Start Levee Mile	6.04
End Levee Mile	6.08
Location	
Category	Earthen Levee
Item	Vegetation
Large Cactus plant on landward slope from LM 6.04 to 6.08

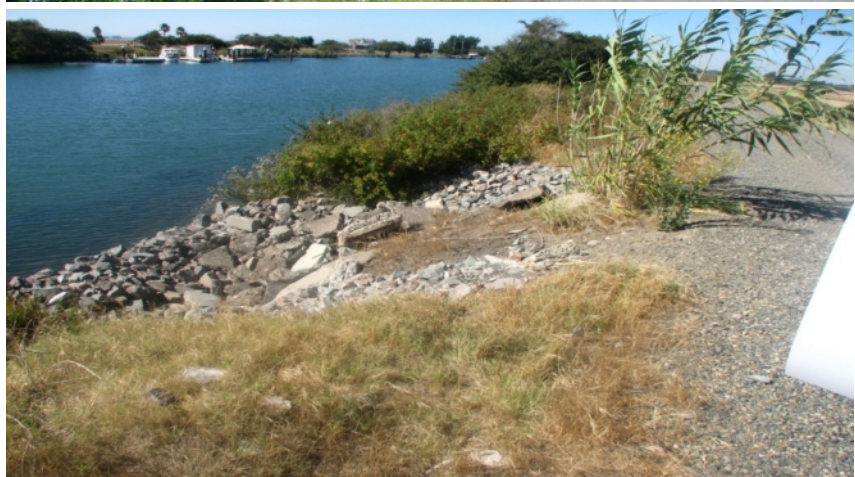
Levee Mile Report Line	76
Start Levee Mile	10.90
End Levee Mile	10.90
Location	
Category	Earthen Levee
Item	Slope Stability
Uncompleted slope stability repair on waterside slope.
